Name Of Dam: LOWER NORTH RIVER NO. 83

Location: ROCKINGHAM COUNTY, STATE OF VIRGINIA

Inventory Number: VA 16503

LEVEL II
PHASE I INSPECTION REPORT
NATIONAL DAM SAFETY PROGRAM

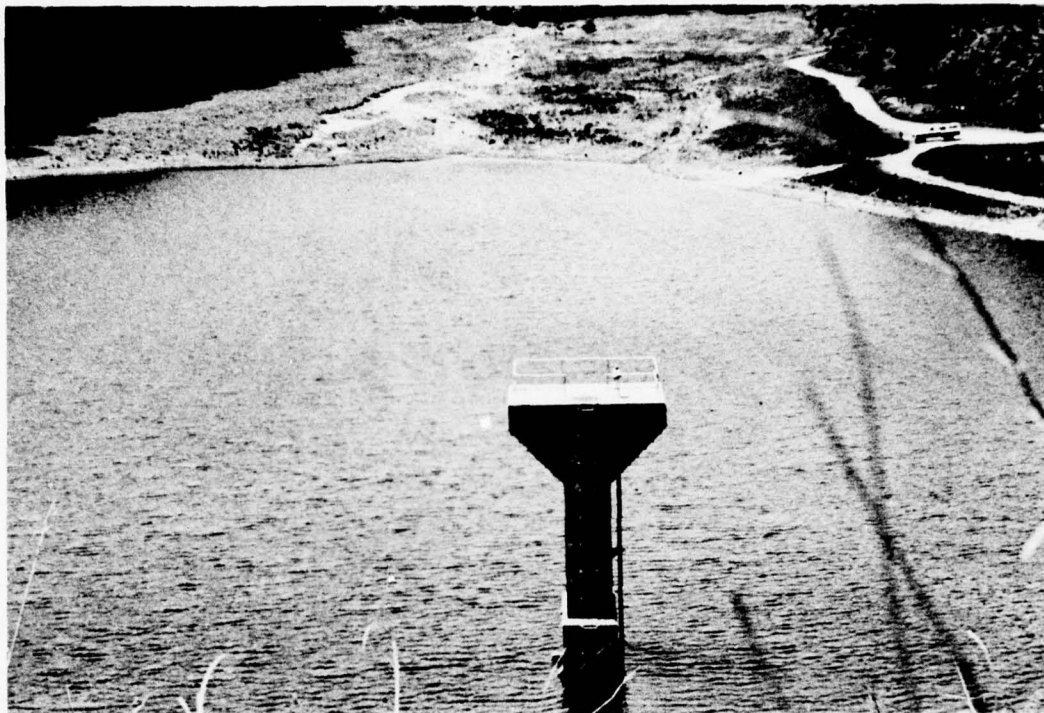
PHOTO 1

3.1.4 Reservoir Area: No serious deficiencies were observed in the reservoir area (see Photo 1).

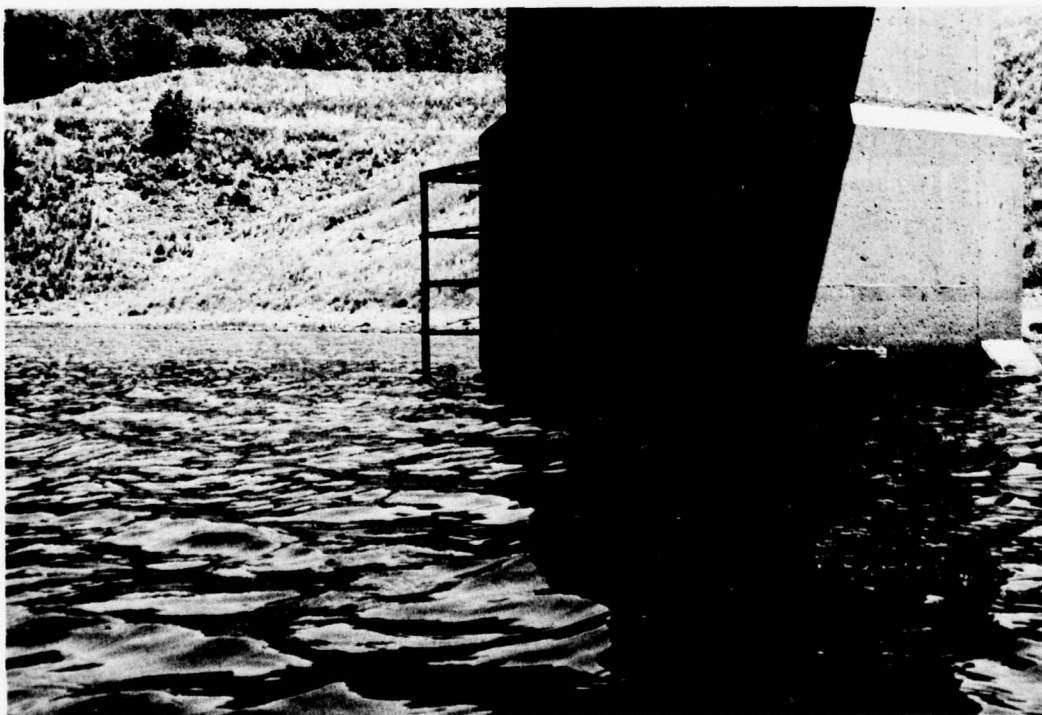
PHOTO 2

3.1.3 Appurtenant Structures: At the time of inspection, some debris was lodged in the low stage trash rack at normal pool (see Photo 2). This debris should be removed as soon as possible, and thereafter periodically in the future, to prevent clogging of the inlet or damage to the trash rack.

- 7.2 Recommended Remedial Measures: The riser inlet and trash rack should be cleaned of debris, and it should continue to be cleaned frequently in the future. Riprap should be placed around the outlet conduit and cradle to prevent further erosion. The cracking and spalling of the 36 inch concrete outlet pipe should also be repaired.

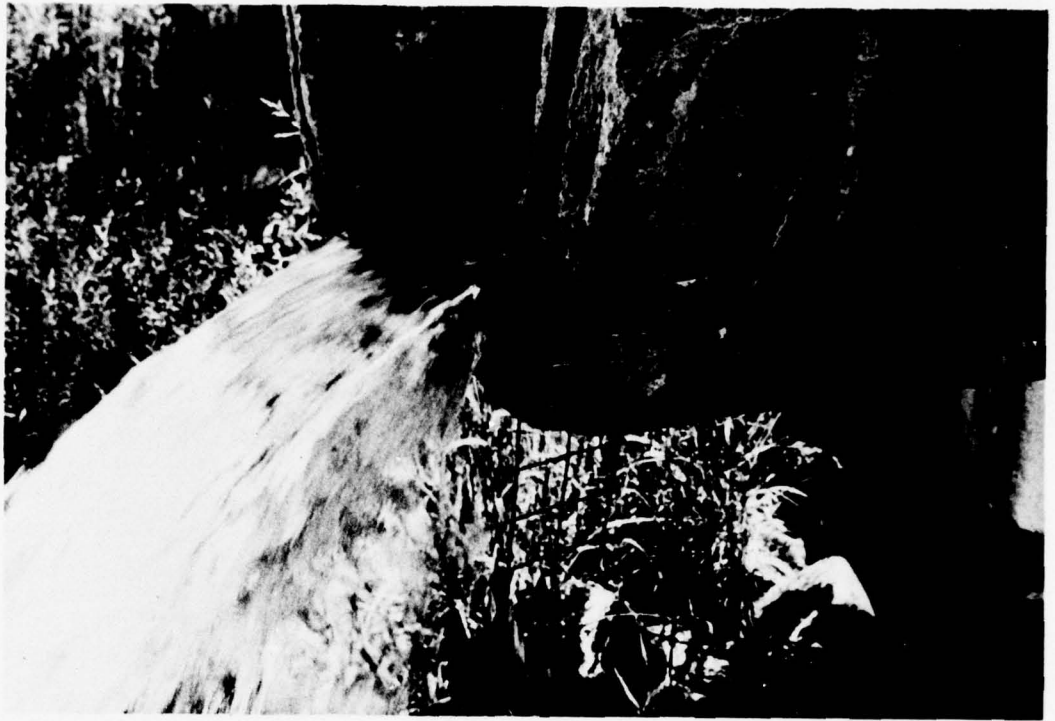
PHOTO 3

The exterior of the outlet pipe has some severe spalling and cracking of the reinforced concrete pipe (see Photo 3).

VISUAL EXAMINATION OF	OBSERVATIONS	REMARKS OR RECOMMENDATIONS
CRACKING AND SPALLING OF CONCRETE SURFACES IN OUTLET CONDUIT	Some severe spalling of the exterior of the outlet pipe has taken place. However, this presents no serious problem at present because it does not affect the efficiency of the pipe.	
INTAKE STRUCTURE HHH-4	Some debris was observed lodged in the low stage trash rack on the concrete riser. Debris should be removed now and be periodically removed in the future. No signs of severe spalling and cracking on the riser.	
OUTLET STRUCTURE	The riprap in and around the stilling basin is functioning properly. No water was observed flowing from the two drains on either side of the outlet pipe.	
OUTLET CHANNEL	The outlet channel is in good condition.	
EMERGENCY GATE	No emergency gates. The only gate is on the upstream side of the riser and is operated from the top of the riser by a hand crank to drain the reservoir.
